**INTELLIGENT  
DESIGN  
ENGINEERING**

August 25, 2016

At your request, I made a site visit to the reference address on August 15<sup>th</sup>, 2016 to inspect the sloping floors and skewed doorways to determine if they are structural concern and to provide a repair plan if necessary. County records indicate that this house was built in 1955. All directions are given with respect to someone facing the front of the house from the street.

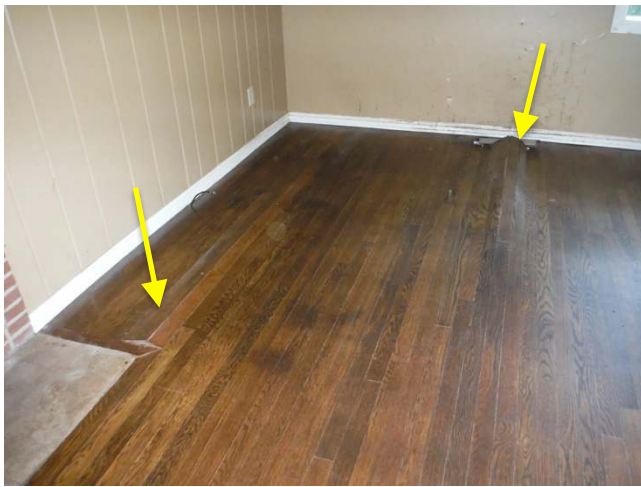
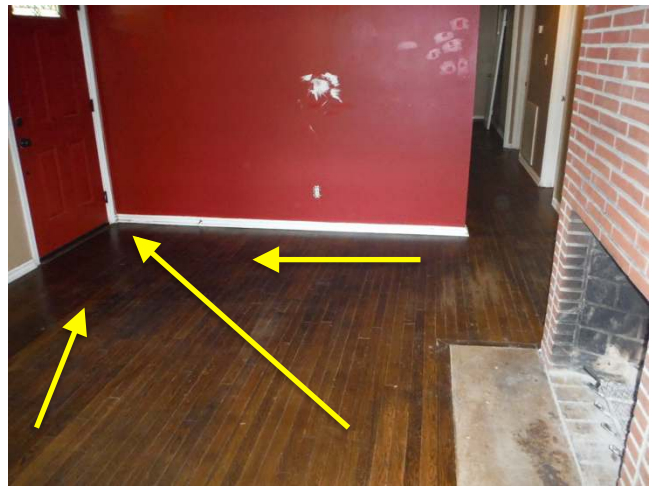
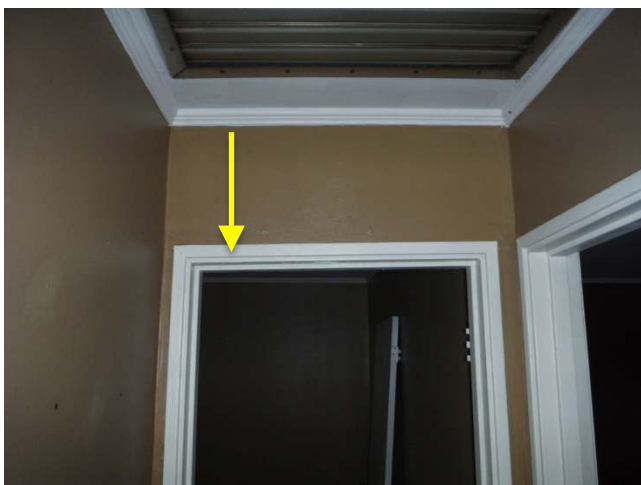
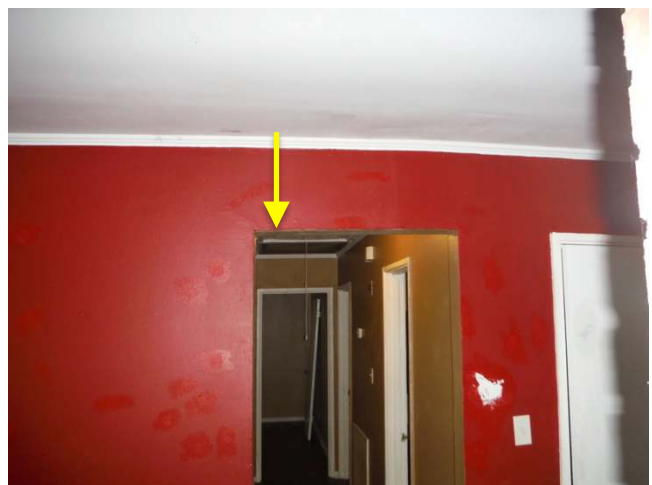
Upon inspection of the interior, there was a noticeable slope in the living room floor, and the hardwood floors have buckled up significantly at a several areas. Several of the doorways are skewed, and there is a hump in the living room floor, as shown in the pictures below.

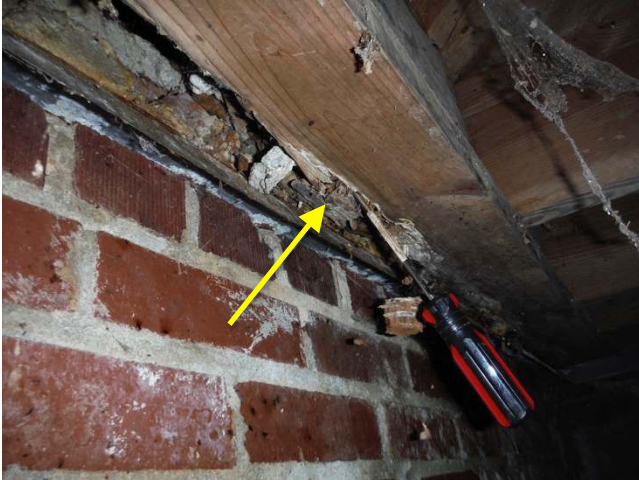
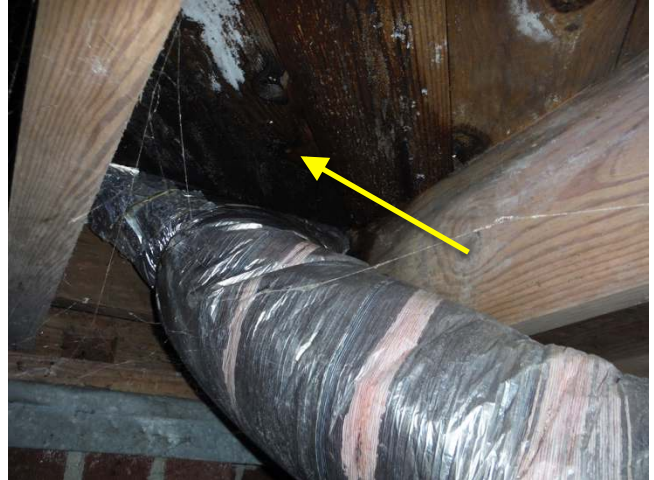
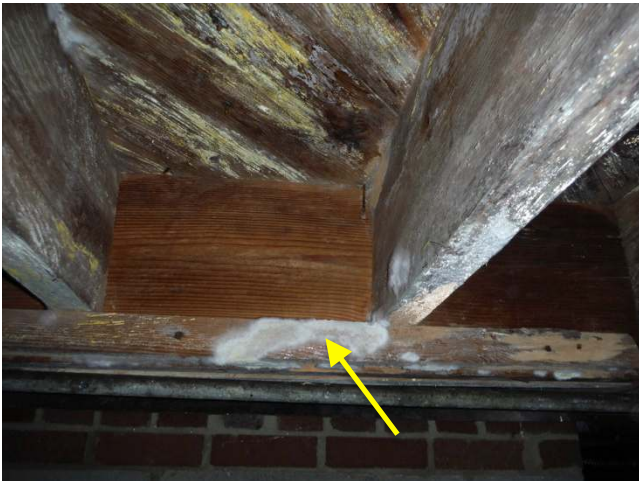
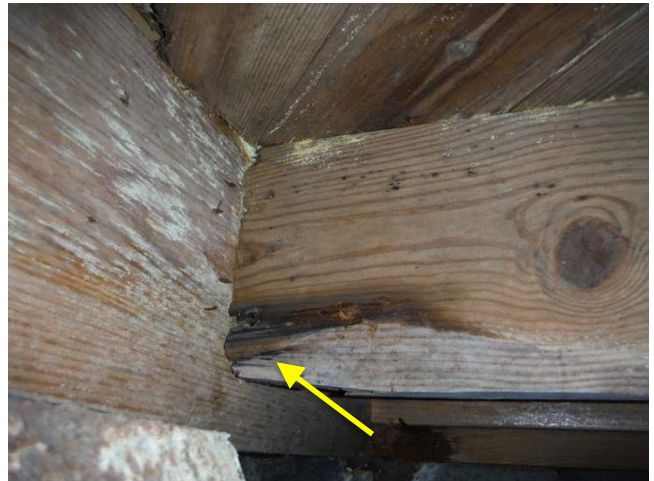
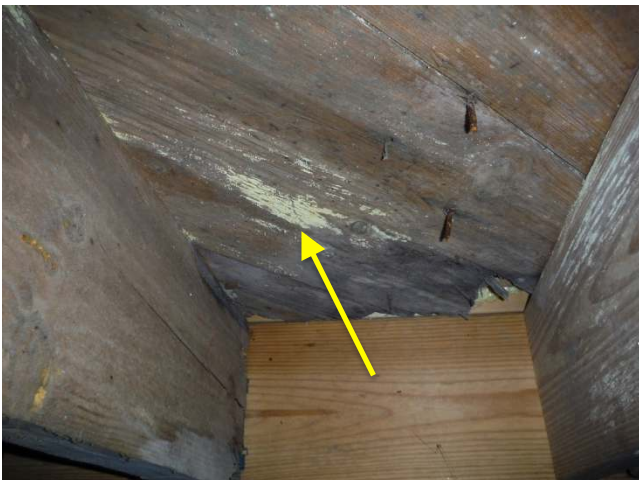
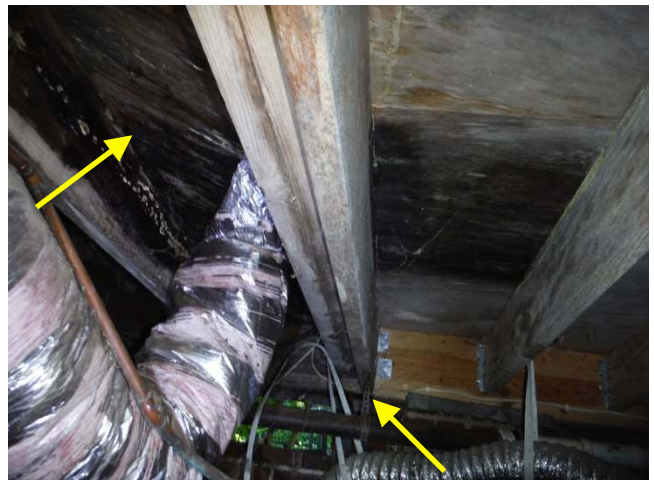
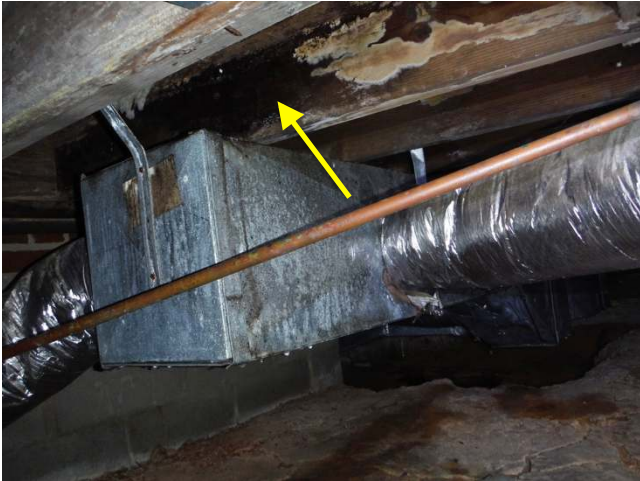
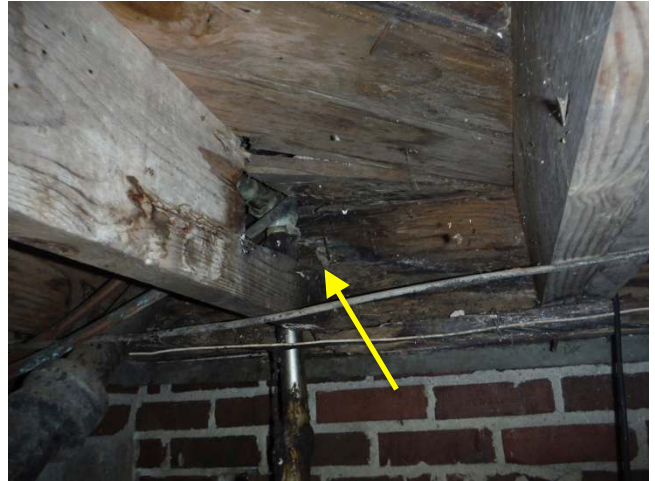
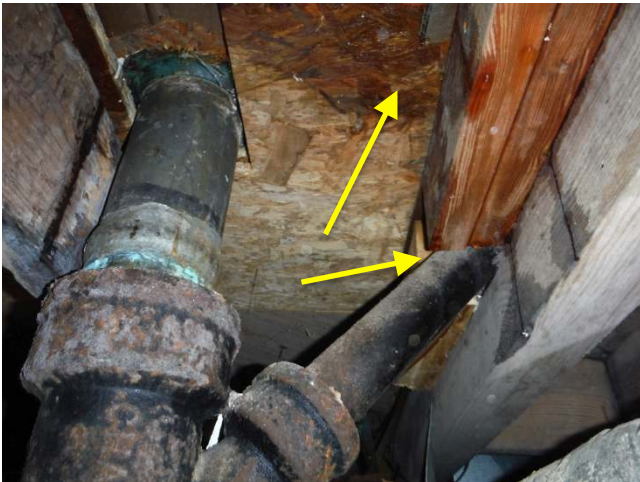
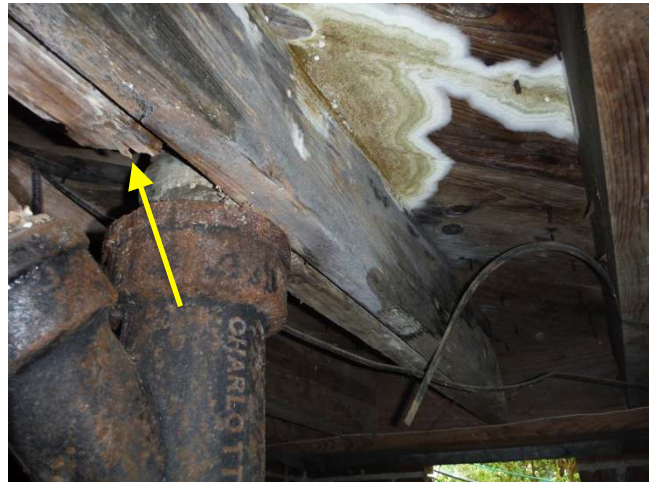
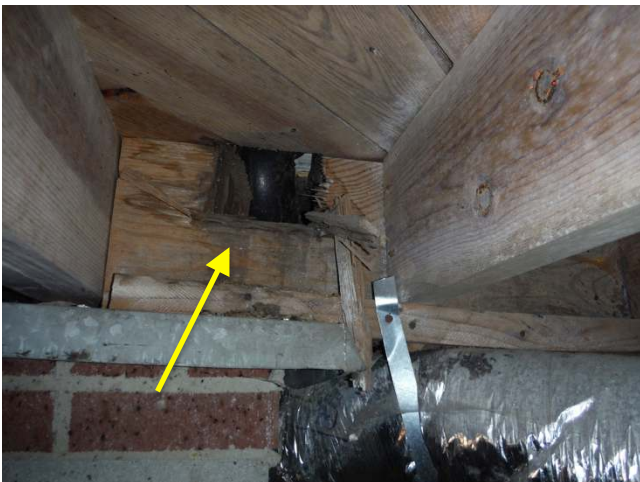
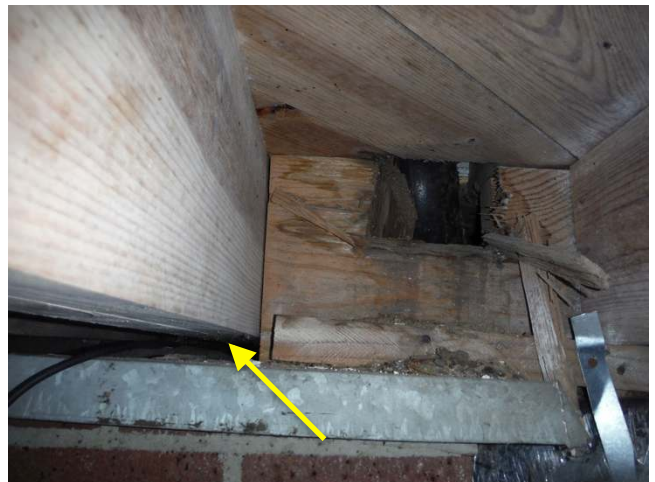
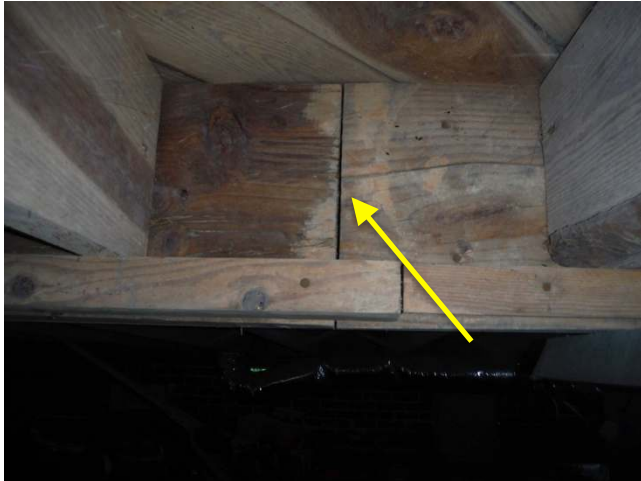
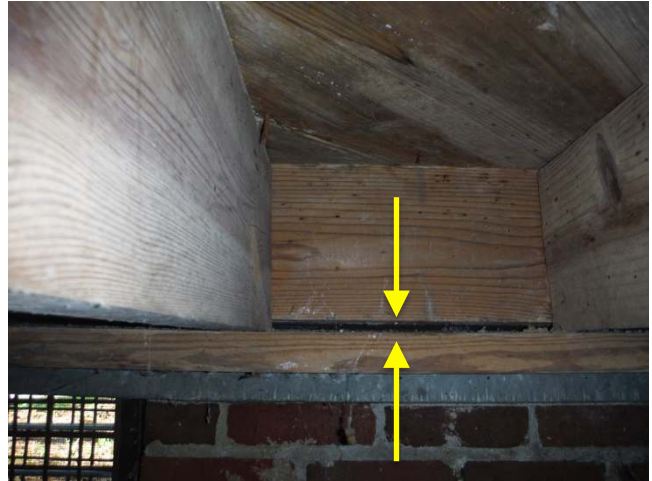
Upon inspection of the crawlspace, several concerns with the framing were observed, including rotted perimeter bands, rotter joists, over-spanned joists, spliced/notched girders, lack of connection between the joist and the band, and a lack of support over the piers, as shown in the pictures below.

At this time, I recommend a series of repairs including replacing the rotted bands and joists, as well as adding dropped girders under the existing over-spanned joists that are being overloaded by the hall walls. See the attached Foundation Repair Plan "A" for locations and clarification of all recommended repairs.

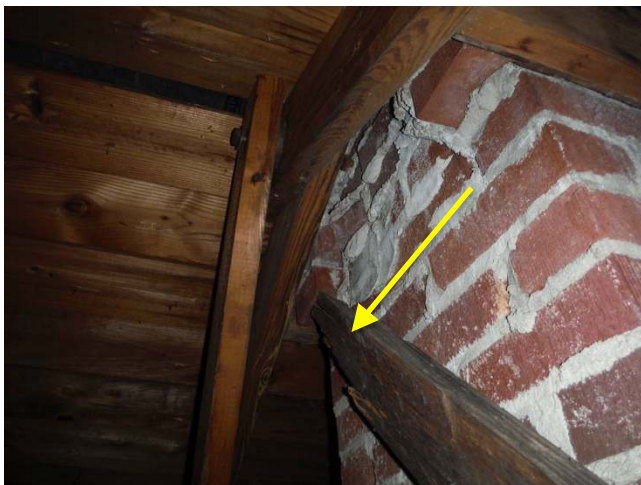
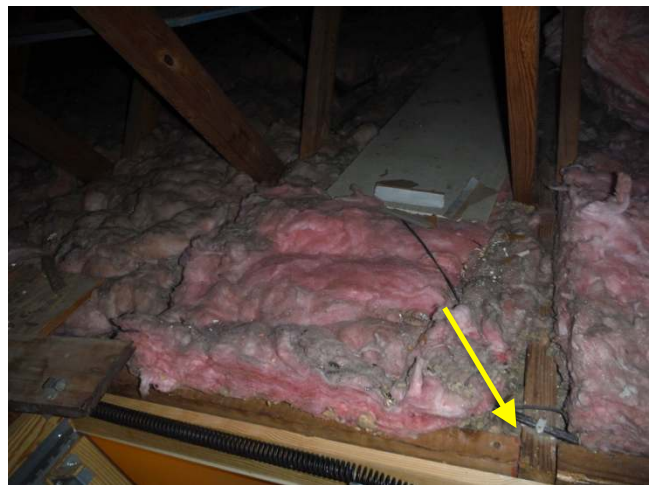
Upon inspection of the attic, the roof truss on the right side of the chimney is damaged and two roof trusses are cut across the attic access, as shown in pictures below.

The roof trusses are site built, and although intended on spanning from the front exterior wall to the rear exterior wall, they are likely relying on the interior walls for bearing. The lack of a bearing wall between the living room and the dining room is likely the reason for the cracking in the ceiling.

- Hang the mid span of the trusses to a new (3)2x10 beam with Simpson TS9 twist straps. Support the right bearing end on the masonry chimney with a steel angle and hung onto a new intersecting (2)2x10 header with an HUS28-3 hanger as required. See the attached Roof Truss Support Detail "B".

- At the trusses around the attic access, I recommend adding a (2)2x4 vertical brace from the peak of the rafters directly down to the hallway wall on each side of the hallway. Fasten the braces to the side of the rafters with (4)16d nails.
- At the damaged truss on the right side of the chimney, the damaged diagonal member cannot be replaced due to the lack of access to refasten to the top of the truss. I recommend bracing the front and back rafters down to the interior wall with (2)2x4 at 60° from the horizontal. Fasten the braces to the side of the rafters with (4)16d nails.
- Fasten all ceiling joists to each other around the masonry fireplace with Simpson A34 clip angles

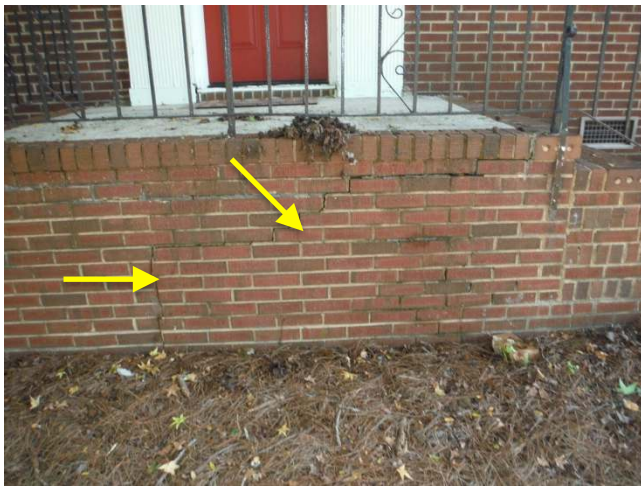
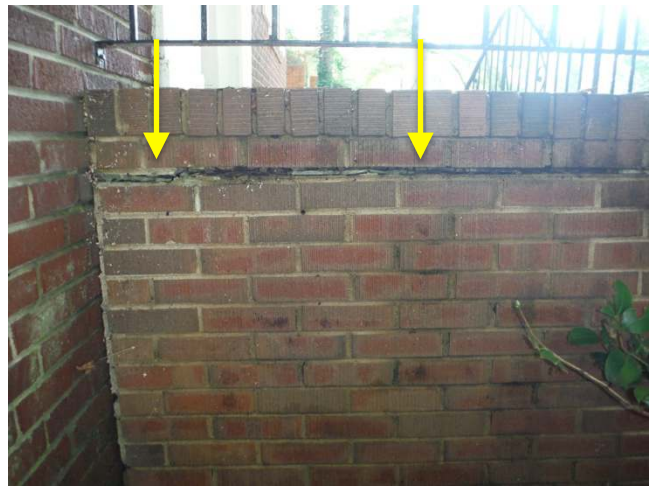
Upon inspection of the exterior, the front stoop was observed to have settled significantly causing 1" wide cracks, as shown in the pictures below. The intersection of the front stoop and the lack of flashing have also created a path for water to penetrate the house and damage the perimeter band, as shown in the previous pictures.

Given the condition of the steps, the cost of repair, the concerns with flashing and the potential for ongoing water damage, I recommend removing the masonry stoop and installing a new front porch. Install the new porch over new concrete footings over solid 2000 psf soil, with new flashing between the porch and the existing band to protect the house band from water penetration, as required by the 2012 NC Residential Code.
